Report on Existing Tower Access and Feasibility Study to Improve Access in Tower

Saint Peter's Church
Wrockwardine, Shropshire

January 2014

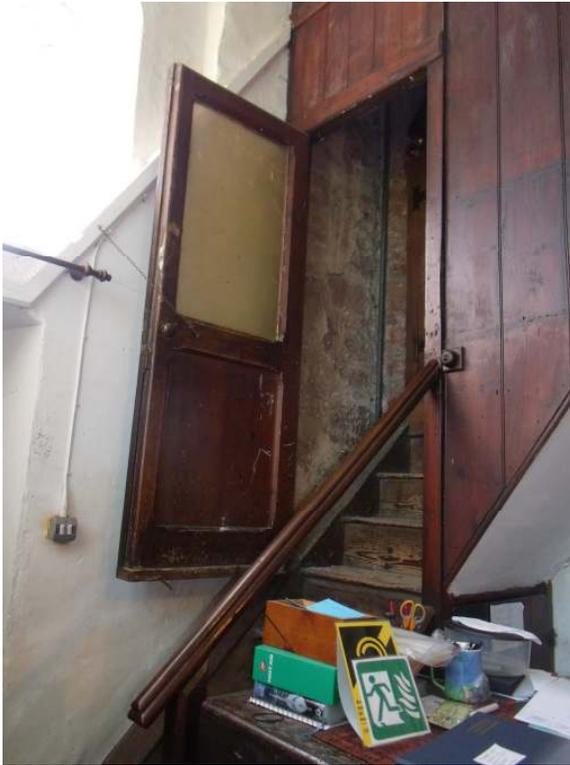
Fig 2 (left) Access door and staircase from ground floor east Vestry at the start of the route.

The door in fig. 2 has a strong closer and it is difficult for elderly and younger people to operate. The steps are evenly spaced and of sufficient tread width.

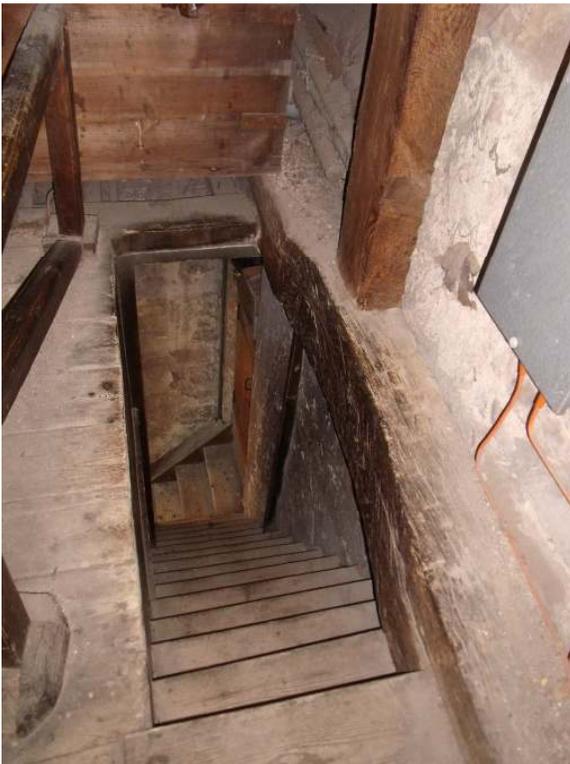
Fig 3 (bottom left) At the top of the first flight of steps in Fig. 2 is a store cupboard. There is no quarter landing and a second flight rises up to the first floor roof space in the east Vestry. A substantial timber tie beam that forms part of the roof truss is located adjacent to the separating wall between east Vestry and Organ Chamber (fig. 4)

There is no quarter landing between the lower flights and whilst this is sufficiently safe for those that are aware of the arrangement, the situation is not ideal.

The tie beam presents an obstacle and potential for injury to those unaware or otherwise distracted.

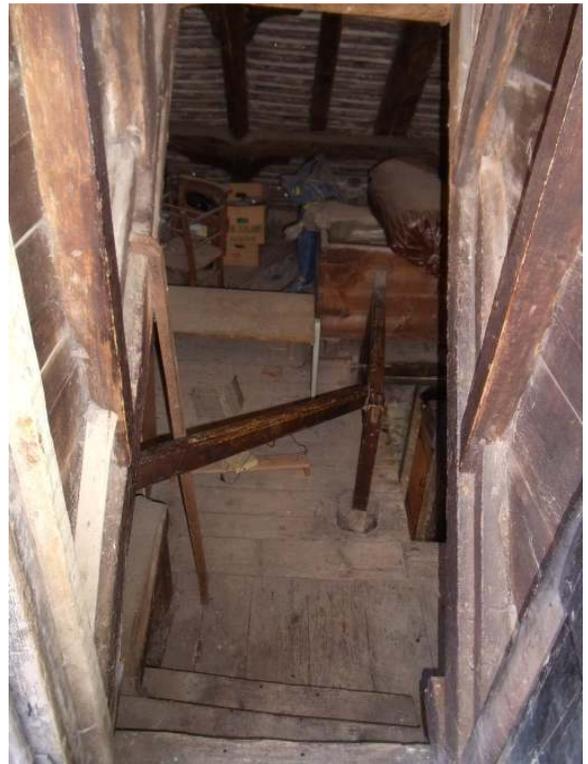
Fig 4 (bottom right) From the staircase in the loft leads to a door in a dormer roof, opening via a short flight of uneven and steep steps. Through the door is an external platform – see next sequence.

Steps leading to the external door are steep, twisted and with no landing area to the door.

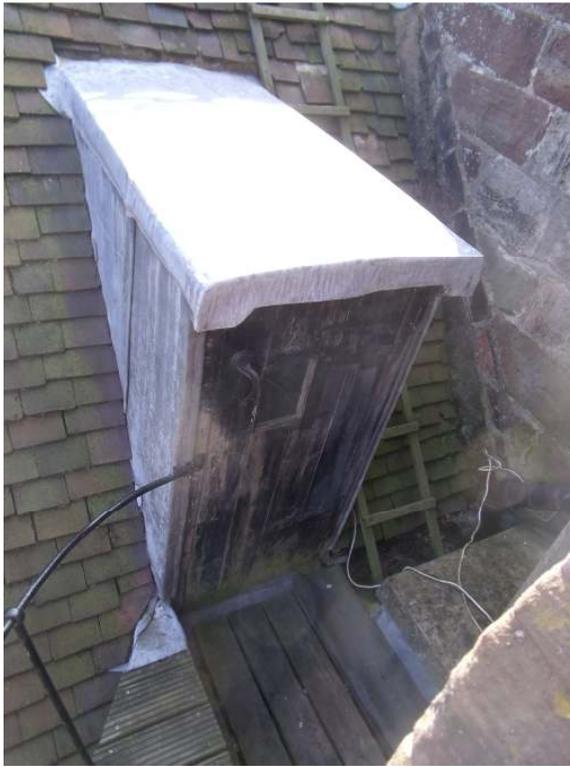
Fig 5 (left) Dormer with external door from east Vestry; the door swings to right and head height is limited. Access continues to the left onto narrow platform ledge.

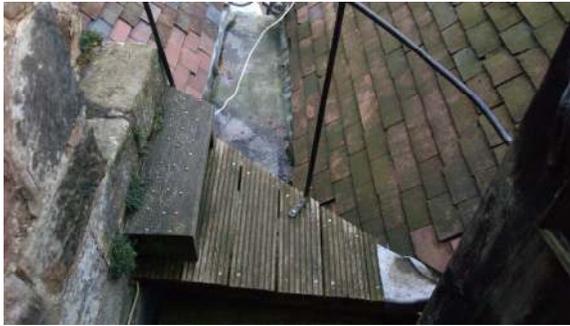
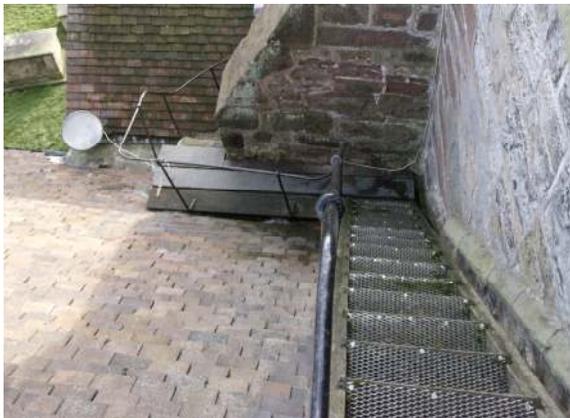
Fig 6 & 7 (bottom left) The narrow platform ledge leads onto steps that form the fabric of the buttress. The valley gutter between east Vestry and Chancel can be seen in fig. 6 between the clay tile roof slopes. Over the buttress a narrow platform along the Chancel valley leads to the start of a steep ladder stair to the Tower door.

The extremely exposed route is slippery, narrow, steep, uneven and winding. Minimal balustrade offers handrail support only and inadequate if a person was to slip. Anti-slip coverings on the floor surfaces are inadequate in places or only help in a single direction of travel.

There is no enclosure which makes the route unpleasant and hazarderous in inclement weather.

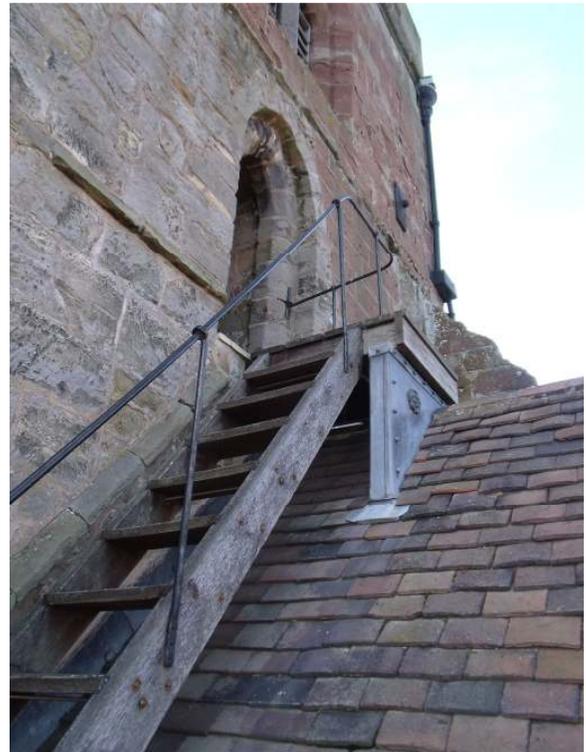
Fig 8 (bottom right) Top of ladder stair lands over ridge of chancel. From the landing and through a narrow opening in the Tower, a few stone steps lead into the Clock Chamber gallery at 3rd floor level (see fig. 9 next page)

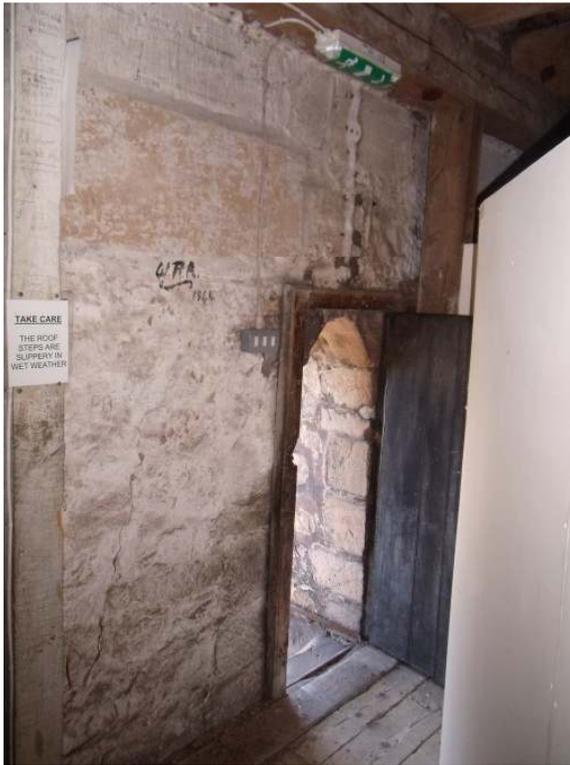
Fig 9 (left) Access into the Tower is from the east at 3rd floor level, through a narrow door (circa. 550mm) with limited head height and a stepped threshold. The white plasterboard seen to the right forms the upper partition to the Bell Ringing Chamber below.

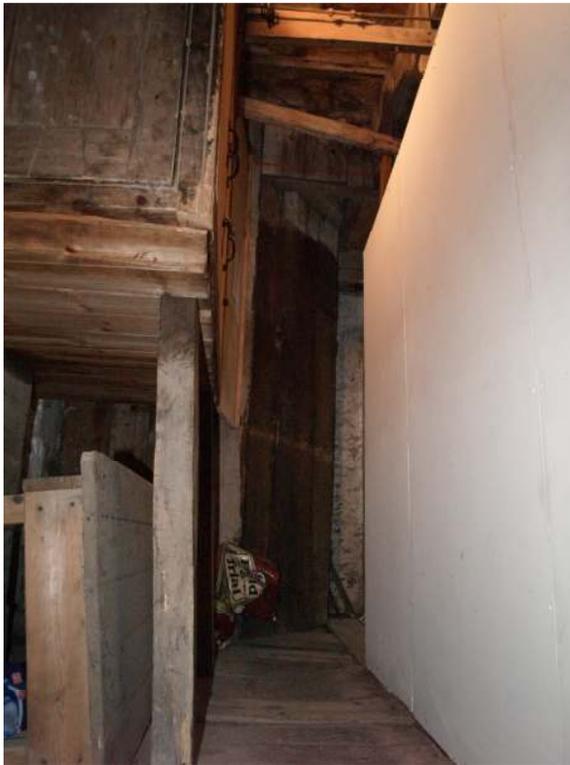
Fig 10 (bottom left) The step ladder in fig 11 is reached via a narrow corridor adjacent to the clock cupboard.

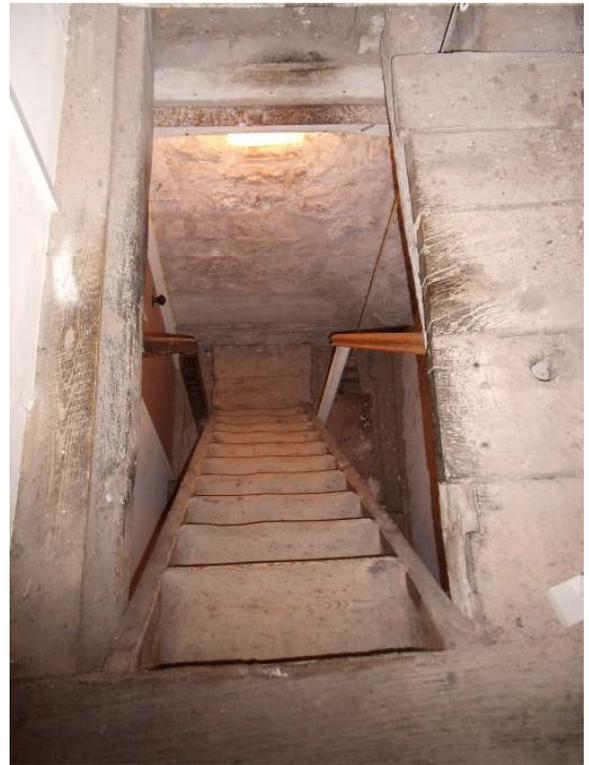
Fig 11 (bottom right) The floor level of Bell Ringing Chamber is reached by descending down a steep stair at the north west corner of the tower.

To access the Bell Ringing Chamber users must ascend up over the chamber to the 3rd floor Clock Chamber gallery, only to descend again back down to access the ropes

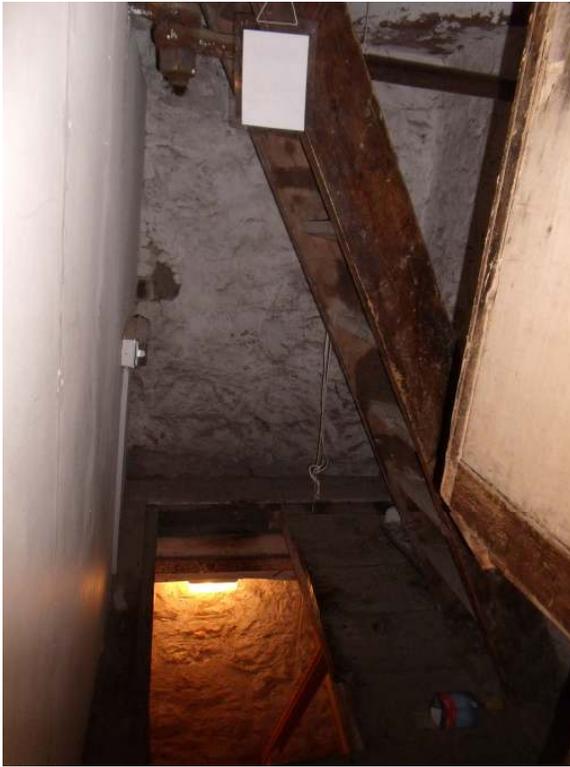
Fig 12 (left) A steep step ladder rises up over the ladder down to the bell ringing chamber; there is no guarding. A metal tie bar penetrates through the ladder which is a substantial obstacle in order to safely climb.

However, the location of the ladder over the opening to the bell ringing chamber means there is a high risk of serious injury. The likelihood of falling is greatly increased by way of simultaneously avoiding the metal tie beam and timber tie beam over. There is greater risk of injury

- Turn ladder 90 degrees and to ascend east to west, over location of existing down ladder to Bell Ringing Chamber. Note, a retractable ladder must be used alternative access down to Bell Ringing Chamber is not made.
- Location of existing trap door may require moving east, in order to avoid tie beam and other structure.

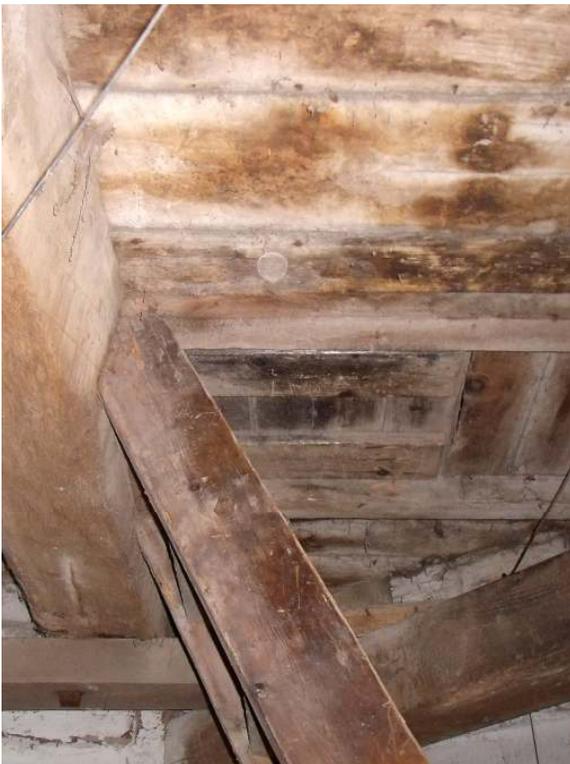
Fig 13 (bottom left) Whilst avoiding the tie bar, users must be careful to avoid the diagonal timber tie beam (lower right of fig 13). The 4th floor Belfry is accessed through a hatch in the floor.

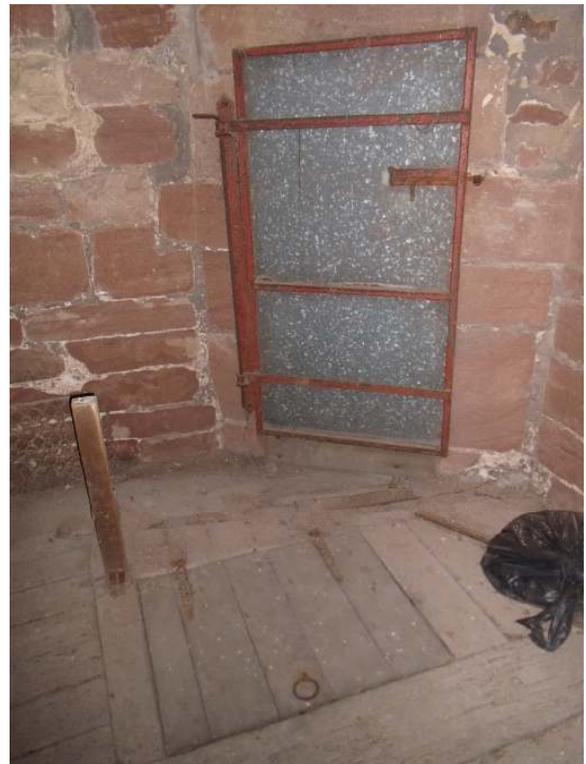
Fig 14 (bottom right) The access hatch can be seen in the lower middle of fig 14. Access onto the external parapet gutter at the top of the tower is through the metal doorcase via a stone spiral staircase in the tower turret.

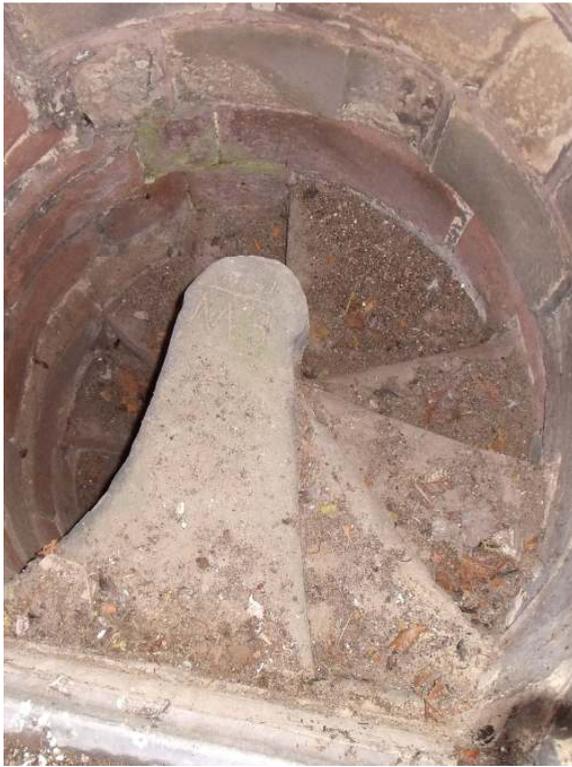
Fig 15 (left) Through the metal door in fig 14 is a narrow stone circular stair, of a historic type to be expected. There is no handrail, however the level of ascent is not too great and the top tread provides a ledge for support.

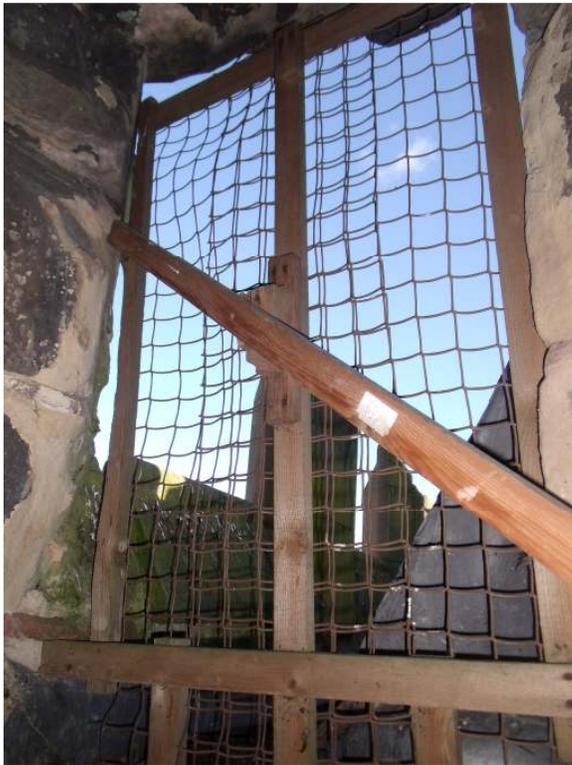
Fig 16 (bottom left) The staircase is not enclosed only protected by a timber framed mesh screen. Difficulty arises from method of removal and refitting, where the only foothold is on the top tread and threshold.

The lack of guarding makes access onto the parapet gutter hazardous and the mesh screen makes the process unnecessarily difficult.

- Replace existing mesh screen with timber louvered door on hinges. Guarding is provided by door opening towards crenellations. Stairwell is protected from weather and is ventilated is by louvered design. Bird mesh on inside face protects stairwell from nesting.

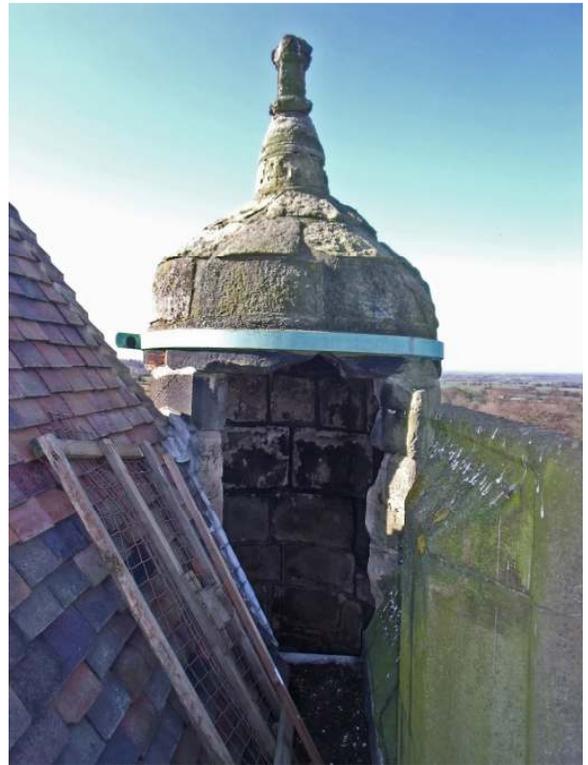
Fig 17 (bottom right) Top of turret staircase, opening onto parapet gutter. Access is narrow and the embrasure of the crenellations is immediately following the turret; this provides little means of guarding. Once removed the mesh screen further reduces foot space.

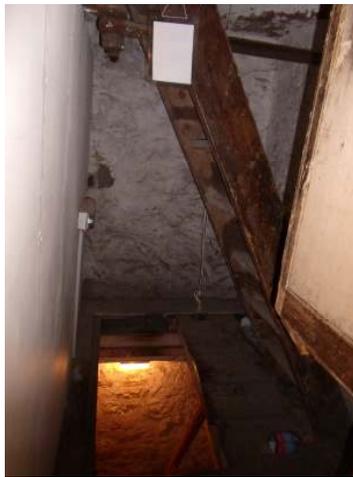
- Options for an alternative location of ladders, to provide access into Belfry is restricted due to clock housing and partition with Bell Ringing Chamber.
- Provision of step ladder to Belfry is assumed to be a suitable method of access, for occasional and periodic maintenance purposes.
- Diagonal timber tie beam, Belfry floor beam and metal tie rods above must be avoided to improve safety.
-

Fig. 29 (top) Reference photo showing existing arrangement.

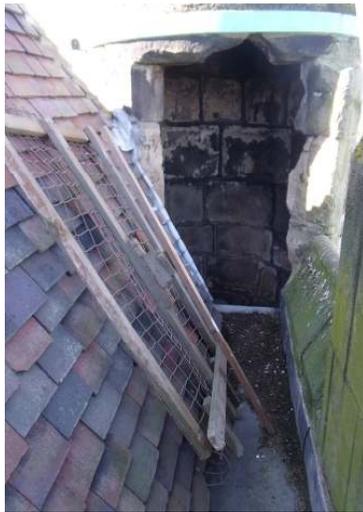
- Provision of existing spiral staircase out onto parapet gutter is assumed to be a suitable method of access, for occasional and periodic maintenance purposes.
- Spiral staircase exposed to the weather with no means to drain water at base of stair.
- Low level guarding at external top landing of stair
-

Fig. 31 (top) Reference photo showing existing arrangement.
