# Donald Insall Associates

## The Church of St Peter, Wrockwardine

Essential Tower Repairs – Bell Chamber Openings  
Addendum to Quinquennial

Issue date: 14<sup>th</sup> November 2013  
Prepared by: Sarah Butler

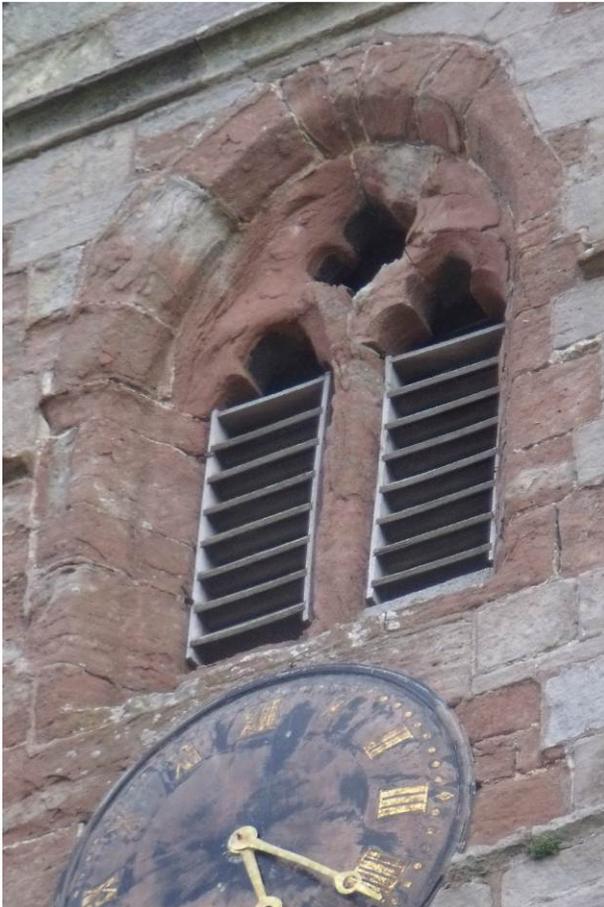
**W2 (bottom left) - External detail of Bell Chamber Decorated opening**

Tracery stones forming the double lancet head and quatrefoil over, are heavily weathered and the form of the tracery has become obscured through lack of definition.

The two tracery stones which sit on top of the chamfered mullion and form the base of the quatrefoil and top of lancet arches are so heavily weathered as to be vulnerable to instability. The north main arch stone has heavy under scouring with a high degree of weathering back from original face line.

The chamfered mullion is heavily weathered and continues to show active spalling.

Access to address essential stone repairs to this opening would afford the opportunity of addressing other essential local stone repairs to this elevation, together with tower works noted in the Quinquennial.

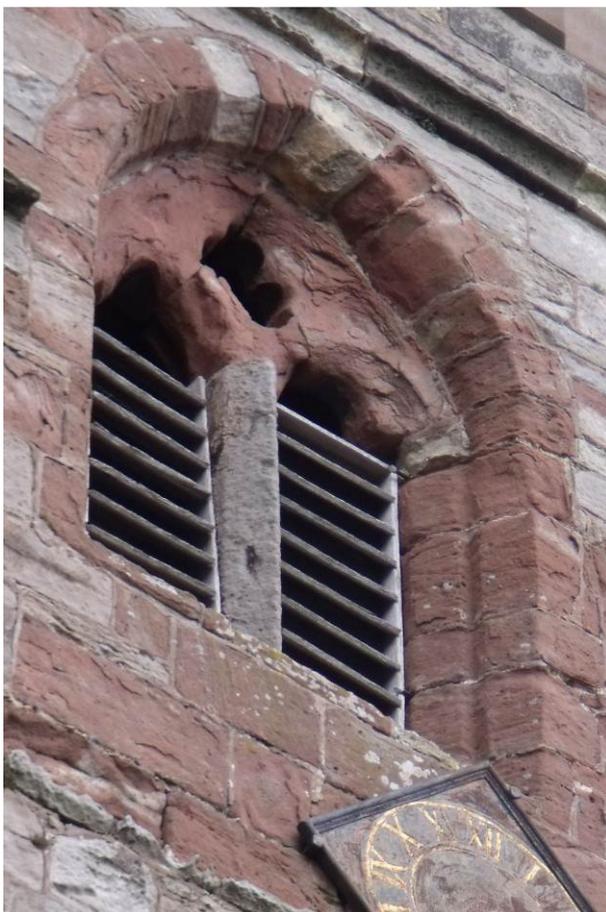
**S2 (bottom left) - External detail of Bell Chamber Decorated opening**

Tracery stones forming the double lancet head and quatrefoil over, are excessively weathered both internally and externally and show on going active spalling of surfaces. These stones are potentially vulnerable to collapse and require replacement.

The two tracery stones which sit on top of the chamfered mullion and form the base of the quatrefoil and top of lancet arches are so heavily weathered as to be vulnerable to instability. There is heavy under scouring with a high degree of weathering back from original face line to both east and west side of main arch.

Access to address essential stone repairs to this opening would afford the opportunity of addressing other essential local stone repairs to this elevation, together with tower works noted in the Quinquennial.

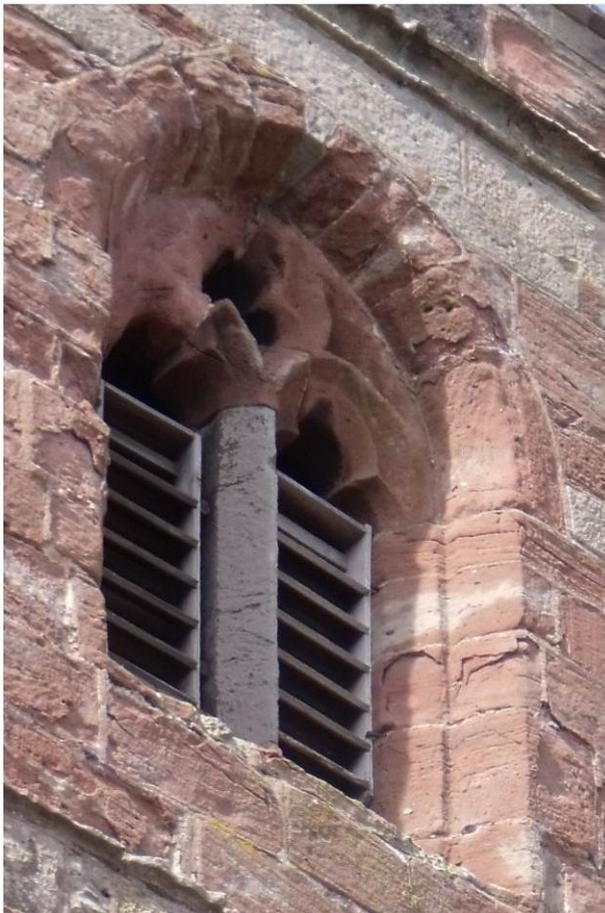
**E2 (bottom left) - External detail of Bell Chamber Decorated opening**

Tracery stones forming the double lancet head and quatrefoil over, are excessively weathered both internally and externally particularly the south side.

The two tracery stones which sit on top of the chamfered mullion and form the base of the quatrefoil and top of lancet arches are both cracked and in a state of collapse/failure. These stones require replacement. There is heavy under scouring with a high degree of weathering back from original face line to the south side of main arch.

Access to address essential stone repairs to this opening would afford the opportunity of addressing other essential local stone repairs to this elevation, together with tower works noted in the Quinquennial.

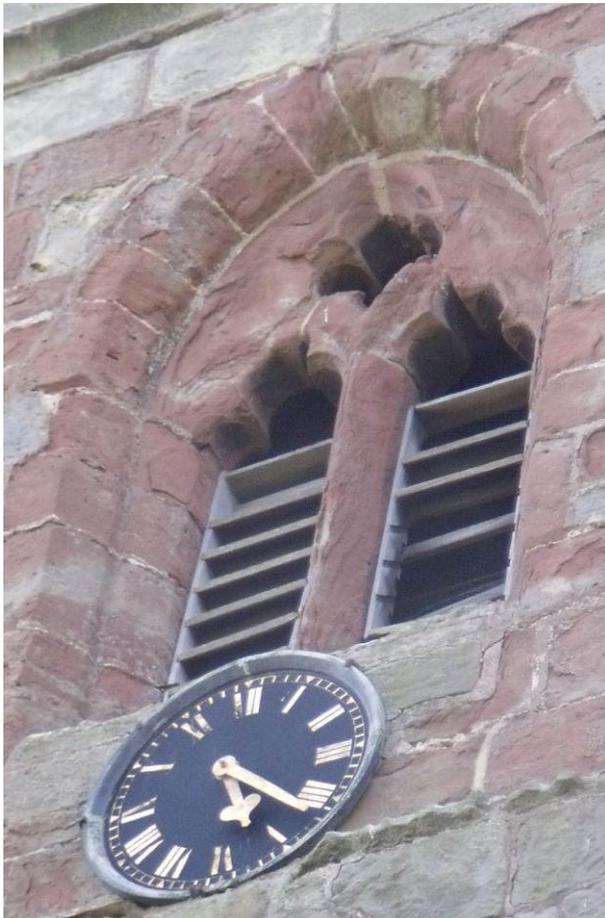
**N2 (bottom left) - External detail of Bell Chamber  
Decorated opening**

Tracery stones forming the double lancet head and quatrefoil over, are heavily weathered and the form of the tracery has become obscured through lack of definition.

The joints of the two tracery stones with the top of the chamfered mullion and adjacent arched tracery stones have become so weathered as to make this arrangement vulnerable to instability.

The chamfered mullion has a scoured surface.

The louveres are in a state of collapse.

Access to address essential stone repairs to this opening would afford the opportunity of addressing other essential local stone repairs to this elevation, together with tower works noted in the Quinquennial.
