Report on Existing Tower Access and Feasibility Study to Improve Access in Tower

Saint Peter's Church
Wrockwardine, Shropshire

January 2014

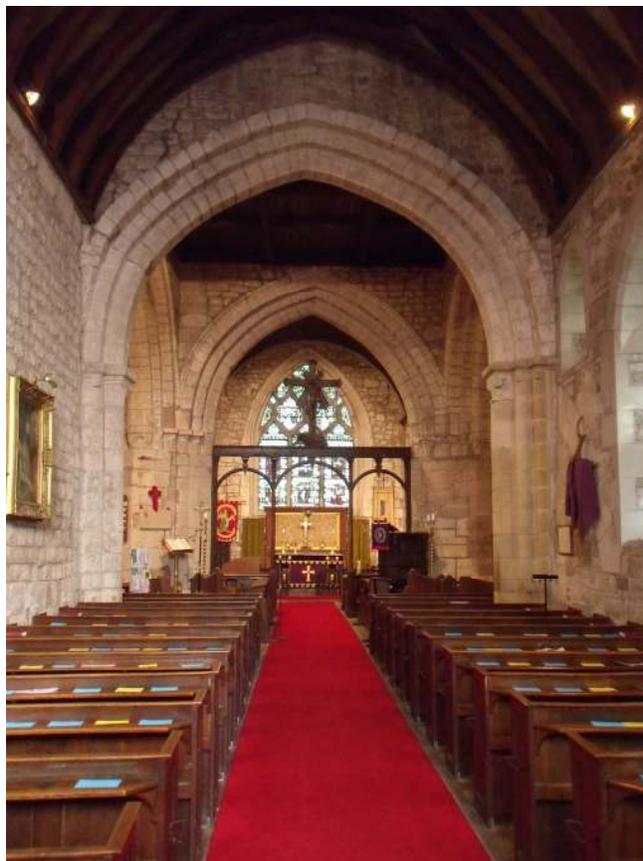
Fig. 1
East axis looking
towards the altar.

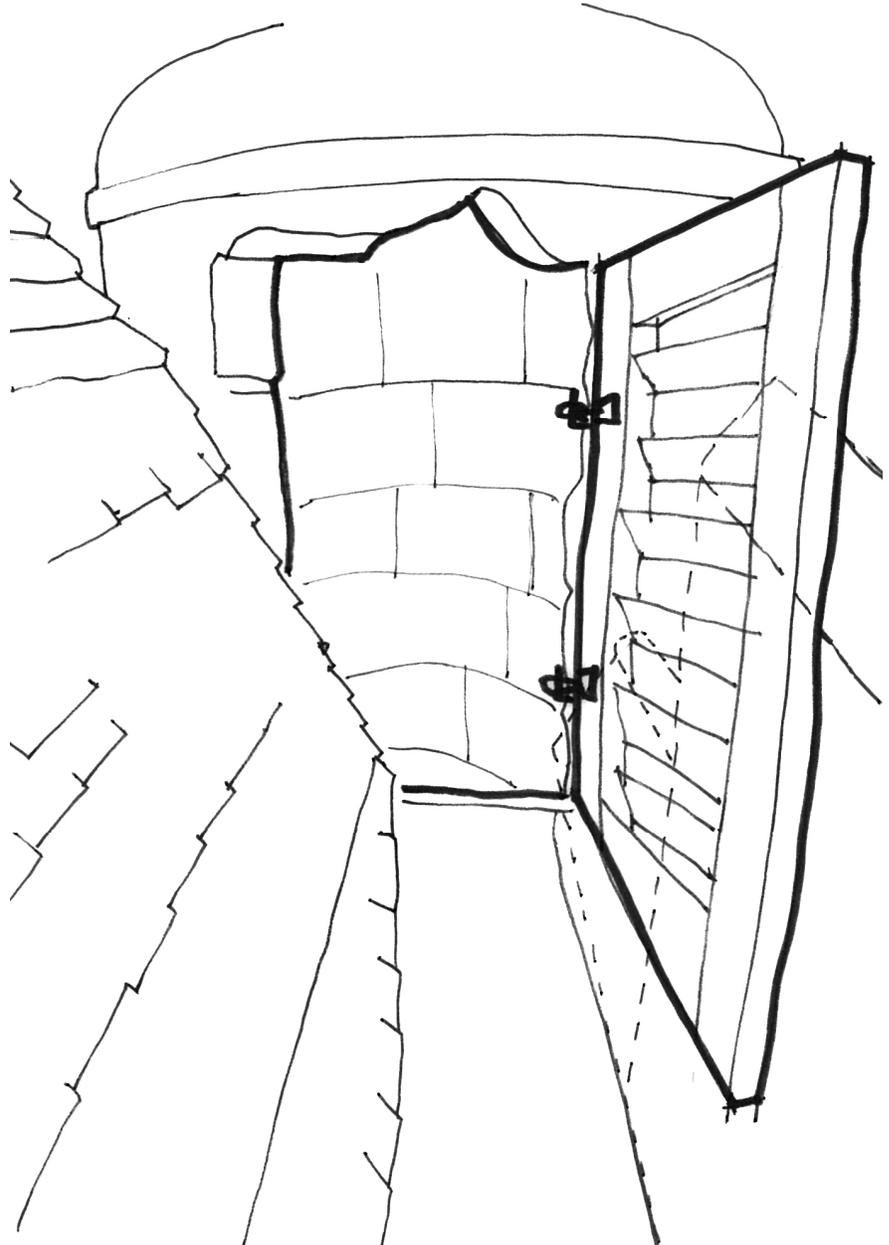
The lack of guarding makes access onto the parapet gutter hazardous and the mesh screen makes the process unnecessarily difficult.

- Replace existing mesh screen with timber louvered door on hinges. Guarding is provided by door opening towards crenellations. Stairwell is protected from weather and is ventilated is by louvered design. Bird mesh on inside face protects stairwell from nesting.

Fig. 32 (right) Proposal showing timber louvered door. Existing crenellations are dashed.
